Failure and overhaul of a historic brick tower

Jacek Hulimka*, Marta Kałuża, Jan Kubica

Department of Structural Engineering, Faculty of Civil Engineering, Silesian University of Technology, Akademicka Street 5, Gliwice 44-100, Poland

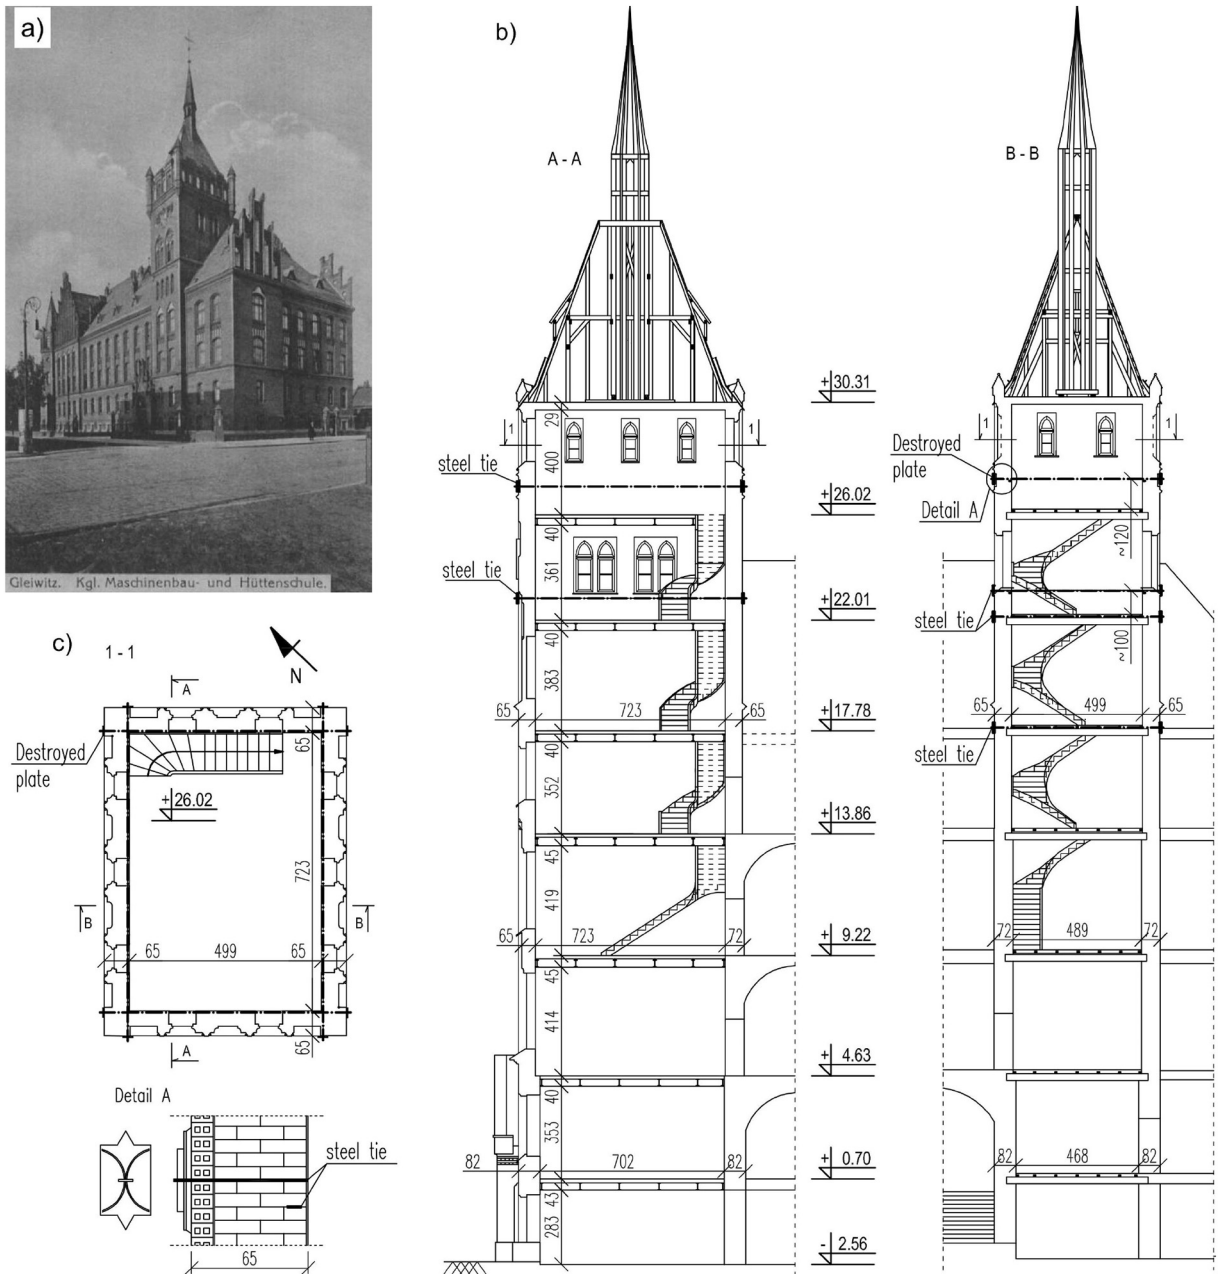
Fig. 1. The tower in question: a) view of the facility before WWII, b) cross-sections of the tower, c) upper section of the tower with a detail of the tie location.

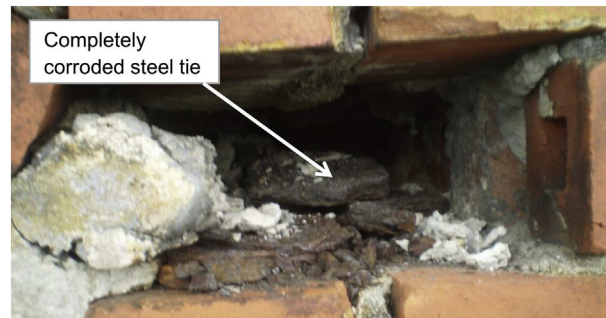
Fig. 2. Total corrosion of the steel tie.

- Total destruction of the steel tie (Fig. 2) in the place of the detached anchorage plate. The failure occurred as a result of a deep corrosive process.

17.5, 21.9 and 22.8 m was good; only local corrosion damage of small intensity was found. At the level of 27.2 m, in the northern and western corners, the ends of the ties were completely destroyed. The corrosion of the flat bars was so large that only single pieces of steel remained (see Fig. 2).

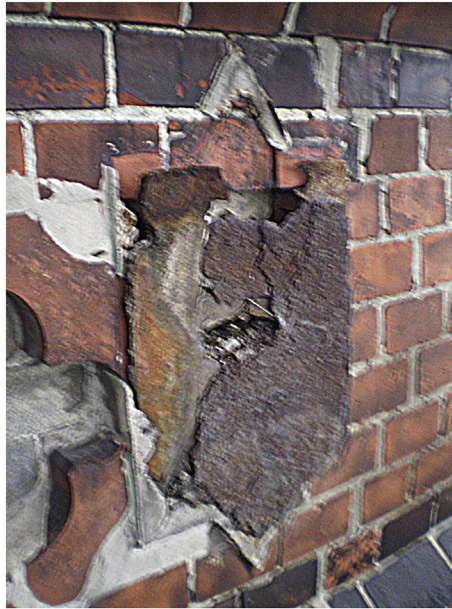
- Bad condition of some other anchoring elements. A few plates were seriously degraded due to corrosion, which caused delamination of the separated steel sheets. In original, the anchorages were not fastened to the façade but, instead, only pressed against it by force caused by the tie, which was equal to zero when the corrosion was serious. Fig. 3 shows the condition of the remains of the anchor plate, which was detached during the inspection. This plate was also located at the level of 27.02 m, on the western corner of the tower. The corrosion products coming off in sheets.

Fig. 3. Remains of the corroded steel anchor plate

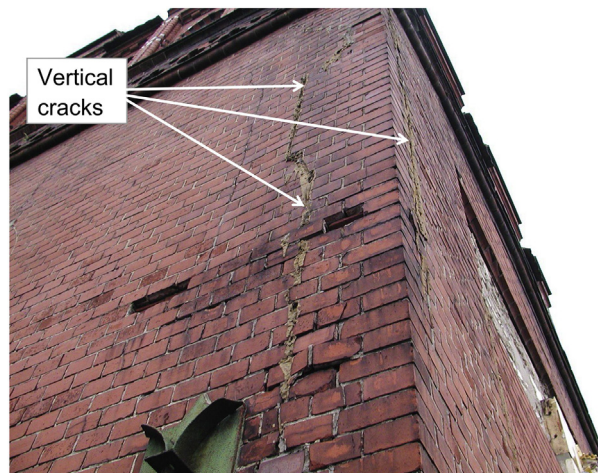
- Very deep vertical cracks along the western corner of the tower (Fig. 4). On the outcrops of some cracks, there were traces of epoxy mortar injected in the past, a large part of which leaked to the outside.

Fig. 4. Vertical cracks in the western corner of the tower.

The first type of damage to the tower occurred as a result of mining activities. Due to mining operations conducted in the past, the tower was exposed to numerous paraseismic shocks. They caused strong vertical cracks in the corners of the tower. This damage covered only the façade layer, which was not bound to the load-bearing wall (it was checked during the renovation works). Those cracks have been repaired in the past, but with low effectiveness. At present, no new cracks of this nature were observed; all noticed cracks arose in the past.

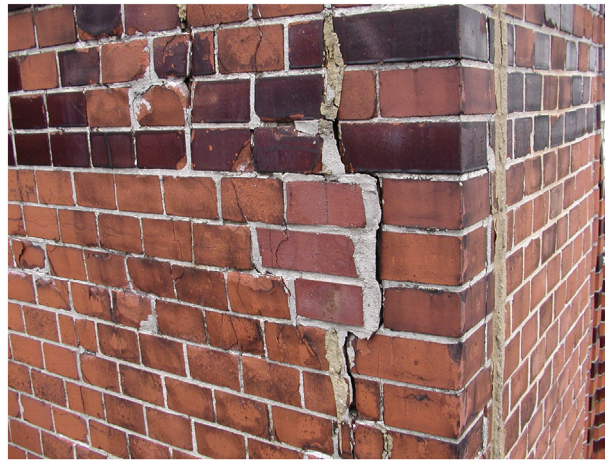
- Dislocation (movement to the outside) of a significant part of the western corner of the tower cut off by the cracks (Fig. 5).
- Very significant detachment and bulge of the façade layer of the wall (on the surface area of several square meters) above the windows of the second highest floor (Fig. 6) on the north-western side; the delamination of the wall was located within the external edges of horizontal perforation of the clinker bricks.

Fig. 5. Dislocated part of the newly built-in bricks (on the stiff cement mortar).

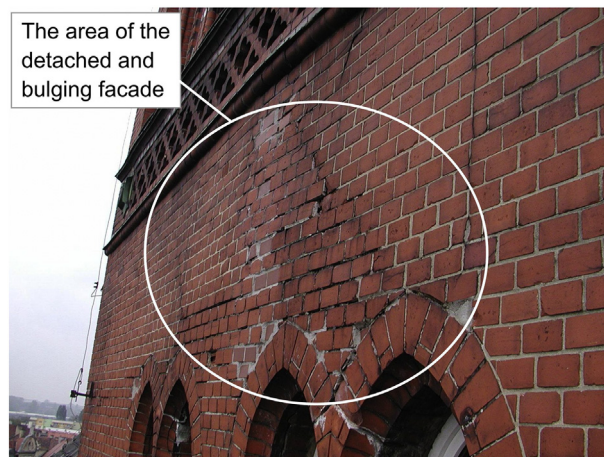
Fig. 6. Detached and bulged part of the north-western façade layer.

Due to the possible existence of further local failure (parts of the façade falling off), the technical condition of the tower was declared to be very bad. The face layer, detached and delaminated in significant portions of the façade, posed the risk of an uncontrolled drop onto the roof and the sidewalk in front of the main entrance to the building (see Fig. 6). Similarly, further steel anchors of the ties could fall off.

Due to the season of the year, the repair of the tower could not start immediately. Consequently, a recommendation was made to immediately install nets on the most dilapidated parts of the façade. Also, construction of platforms beneath the most damaged area (Fig. 10) was ordered to prevent clinker and ceramic elements falling onto the roof and the surroundings of the building (see Fig. 6).

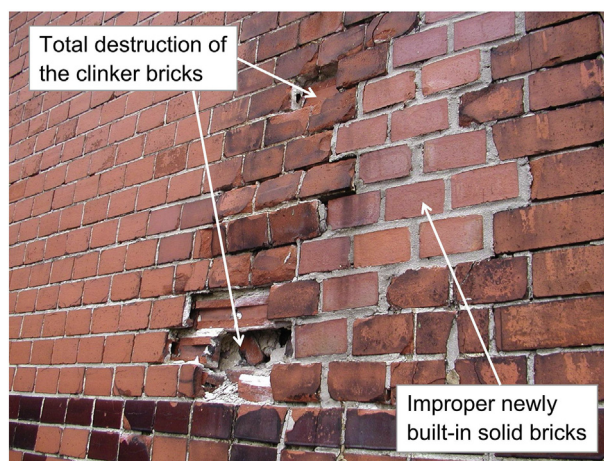
- The numerous local loosened clinker bricks and cornice elements in both inspected walls (Fig. 7), at the level of the highest floors, and falling pieces of the clinker bricks had damaged the main section of the roof cover.

Fig. 7. Very strong destruction of the clinker bricks.

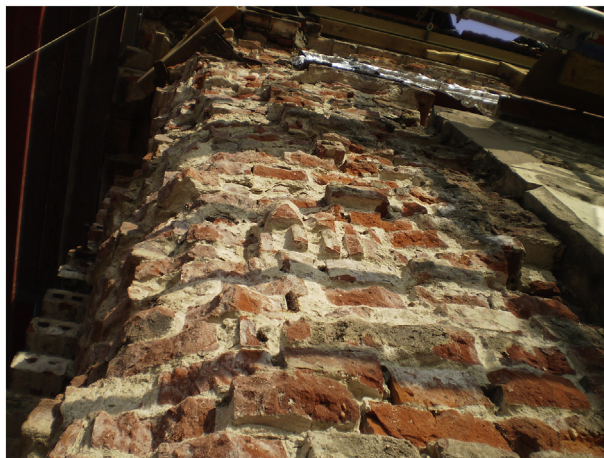
- Destruction of the solid bricks in the load-bearing layer covering only the outer part of the wall (Fig. 8); this type of failure was in large part identified later, during repair works, after the damaged façade was removed.
- Significant destruction of the mortar, down to the depth of approx. 50 mm.

Fig. 8. Destruction of the solid bricks visible on the surface of the load-bearing layer.

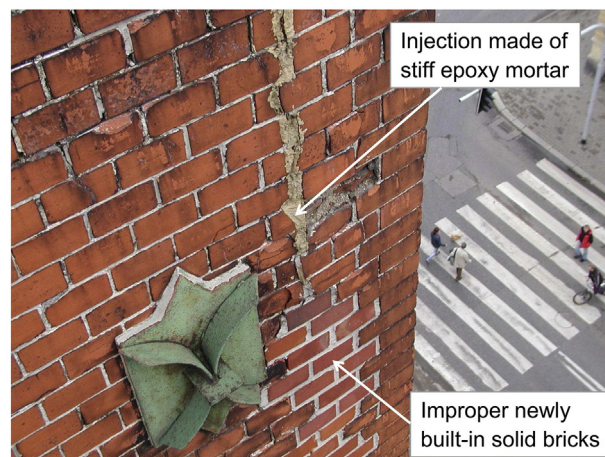
An additional cause of the damage in the façade layer was the improper performance of repairs in the past. In those repairs, bricks with cement mortar were used, which resulted in parts of the wall characterized by lower deformability, thus causing detachment of the newly repaired layer of the wall from its internal part. Additionally, cement and cement-lime mortars are characterized by significantly lower steam permeability; as a result, moisture is evacuated from the wall not through the mortar in the joints (as it should) but through masonry elements, thus causing their damage and the resulting failure. Moreover, those components were not properly bound to the original brick structure. As a result, the original façade was locally burst through thermal stress and steam

Fig. 9. Improperly made repair works, which are escalating the further destruction.

The visible attempts to inject epoxy resin mortar into some of the cracks (Figs. 4, 5, 9) were unable to join the cracked parts of the structure. On the other hand, due to the significant difference in rigidity between the original mortar and the injected material and due to the injection under pressure, the repairs contributed to the local deterioration of the condition of the structure. The rigid bands of the epoxy mortar acted as wedges, especially at fast changes in the temperature of the façade.

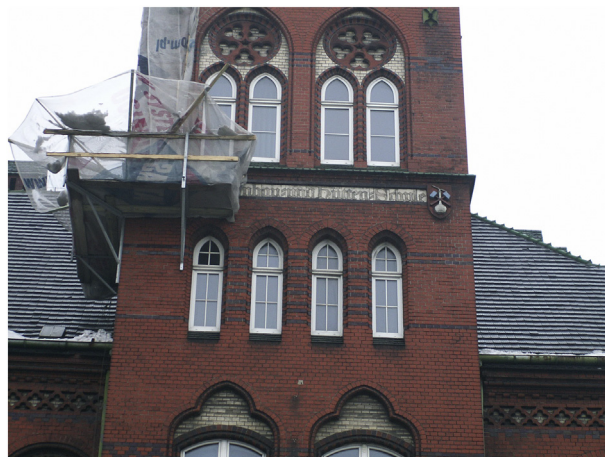
Fig. 10. Temporary steel-wooden platform and protecting nets.

Another action that had to be performed immediately was to cover the main entrance to the building located in the wall of the tower with a wooden roof. This place was directly exposed to the risk of falling fragments of the façade. At the same time, works started on the design for the repair, together with the necessary approvals (the building is listed in the register of historical monuments). The works described above were performed on an immediate basis in the course of preparation of the expert assessment report.

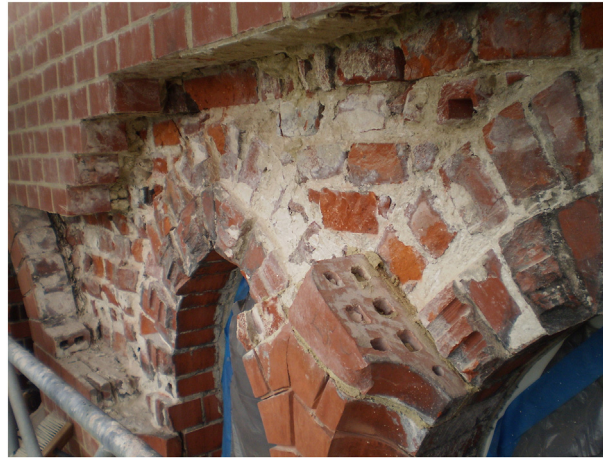
Fig. 11. Reconstruction works.

The scope of the repair of the façade and the load-bearing wall included: manual demolition of all the damaged or loose façade clinker bricks, chipping off and removal of destroyed bricks in the load-bearing layer and then securing of exposed surface and replacing the missing parts of the load-bearing layer (with solid ceramic bricks of class 15 and lime-cement mortar of class M7). Stage of demolition and protection works are shown in Fig. 11. After the load-bearing layer of the external walls was repaired, the missing parts of the façade layer were replaced with undamaged shapes that had been disassembled. Also, all surfaces of the façade were mechanically anchored to the load-bearing layer with additional steel reinforcement, which is a typical action. The repair system based on the special spiral rods made of austenitic stainless steel Grade 316 was used. At the final stage of the works, the entire surface of the façade was cleaned, pointed, and secured with water-repellent products.

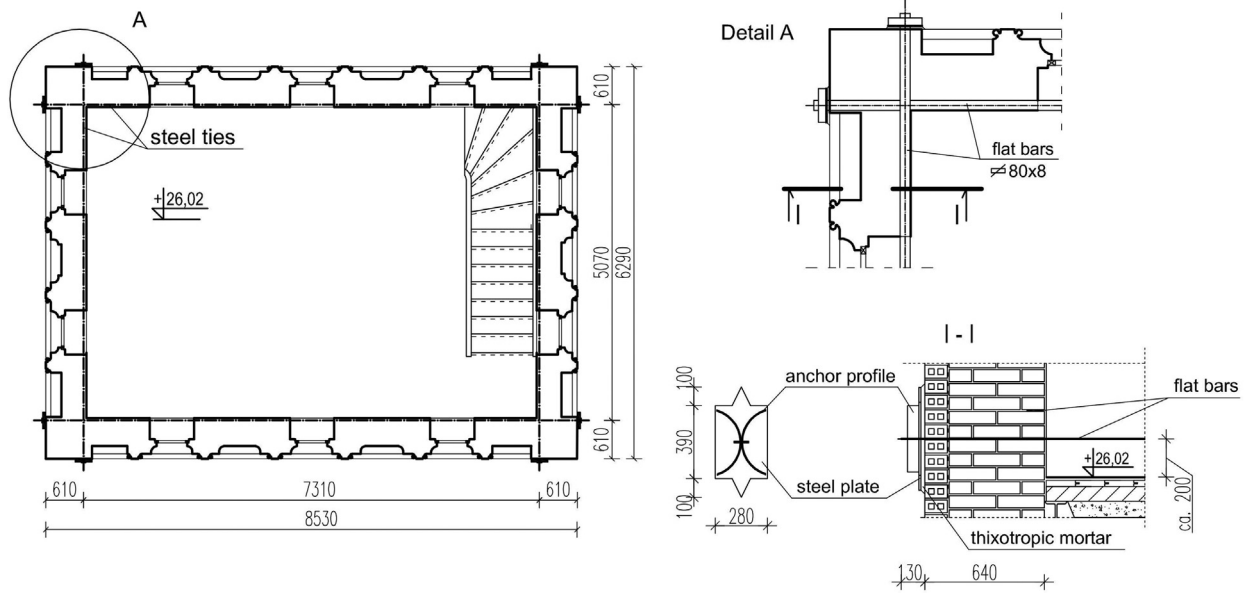
Fig. 12. Detail of the new steel tie; location and overall view.

Strong corrosion damage identified on the ties located at the level of 27.02 m and their improper location (more than 1.15 m above the plate) required the installation of an additional set of four ties located immediately above the floor of the highest floor. Due to the historical nature of the building, the restored elements were identical with the original ones. The flat bars of the ties were located in the joints between the bricks (at the internal surface of the walls) and the remaining gaps were filled with appropriate mortar dedicated to the renovation of historic buildings. The appropriate tension in the ties was achieved by pushing wedges between the face of the wall and the anchoring plate and then by stabilizing the plate by filling the free space with cement mortar with strong thixotropic properties. The old steel ties have left and only the loosened parts of the rusty steel pieces have been removed. New anchorage plates were mounted. The new set of four ties was built-in to replace the corroded elements. The location and construction of those ties are shown in Fig. 12.

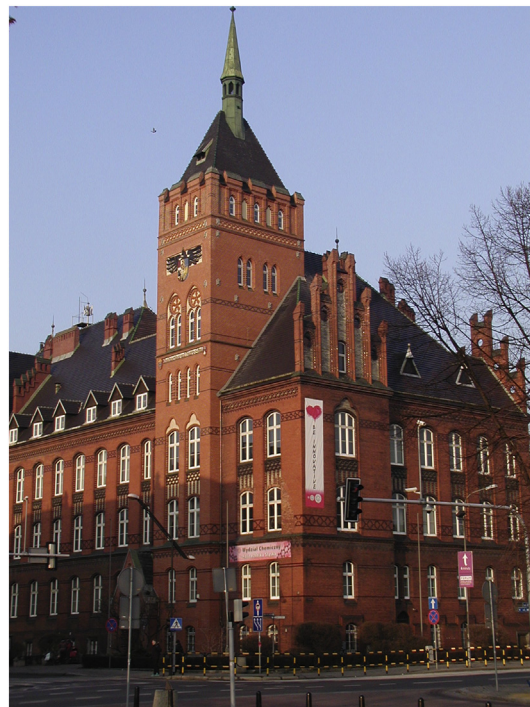
Fig. 13. General view of the renovated tower.

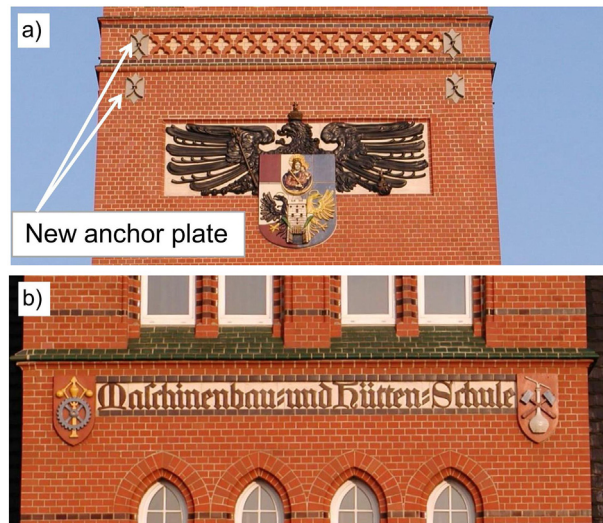
Fig. 14. Renovated details: a) new anchorage plates, b) architectonic details.

group of ties) are visible. Both Fig. 14a and b show renovated architectural ornaments.
